Technical Report
MECSE-18-2006

STI Building Screened Room-Testing for Attenuation

**Measurement of the Electromagnetic
Screening Effectiveness of the New
Screened Room in the STI Building at
Monash University**

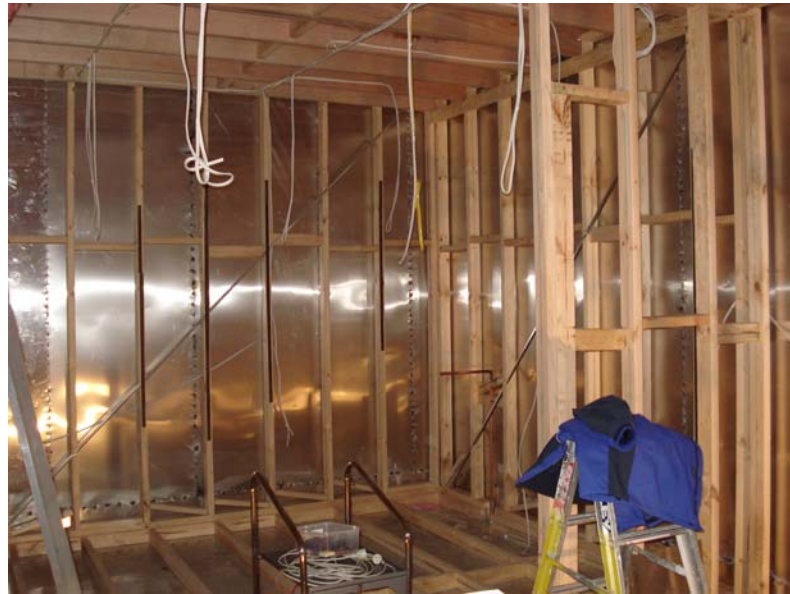
Figure 1. Inside the STI screened room during construction.
Note the welded seams between the adjacent aluminium lining panels.

The interior of the new screened room in the STI building, is to be electromagnetically isolated from the outside world. To achieve this isolation the screened room is completely lined with aluminium panels. The joints between adjacent panels overlap by 100 mm and are spot welded to each other every 50 mm along the seam between them (Fig. 1).

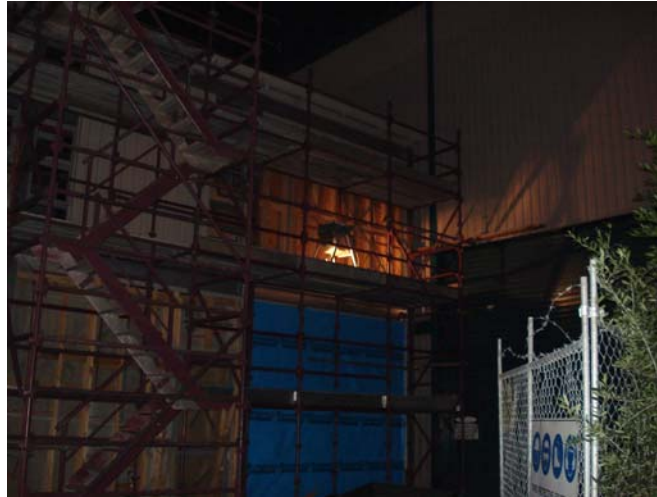
Figure 2. The outside of the STI screened room during attenuation testing. Accessed via the builder's scaffolding, the light shows the measurement equipment outside the screened room.

- a) on the north wall, accessed outside the screened room using the builder's scaffolding (Fig 2)
- b) the east wall of the screened room, accessed outside the screened room but internal to the STI facility, using a scissor lift (Fig 3)
- c) the floor of the screened room, accessed outside the screened room but inside the STI building, using a ladder in the room under the screened room
- d) the screened room door (in the east wall), accessed from outside the screened room from the stairs and landing (Fig 4)

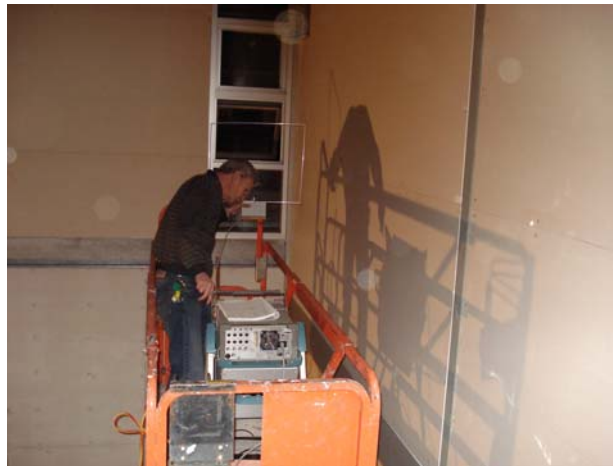
Figure 3. On a scissor lift one floor up, measuring outside the east wall of the screened room, inside the STI building.

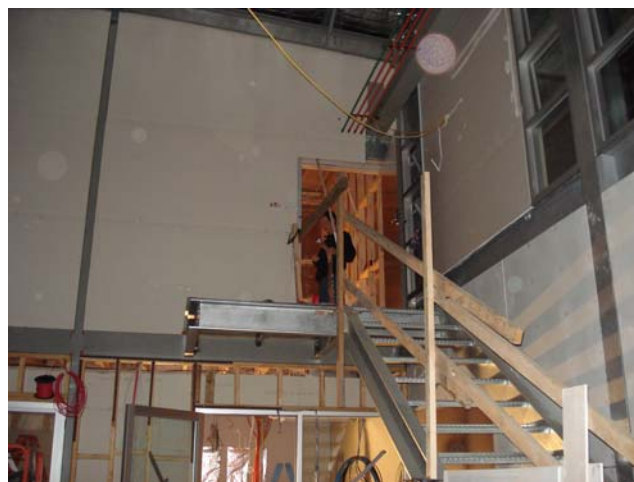
Figure 4. Measuring attenuation around the screened room door from the stair landing

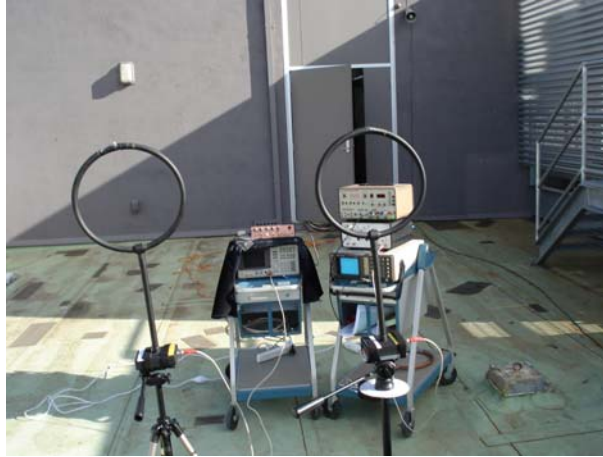
Figure 5. Calibrating the loop antennas.

The loop antennas were mounted on tripods and set to be copolar and at the required distance apart. One loop was sinusoidally driven at the required frequency by a BWD 604 Minilab function generator connected through its internal power amplifier. The signal level was measured by a CRO in parallel with the loop. The receiving loop was connected to an HP 8591E spectrum analyzer set to the appropriate frequency and a 1 kHz bandwidth. The received signal level was measured in dBm.
